Research Study on the Sinking Sequence of MV Estonia

WP2.2 Definition of foundering scenarios
WP3.5 CFD Computations and validations
WP4.1 Comprehensive modelling of MV Estonia

Project No.: *SaS0603-VIES01*
Reference No.: *VIES01-RE-001-AJ*
Report Date: *09 September 2006*
Report Type: *FINAL*
Report Status: *CONFIDENTIAL*

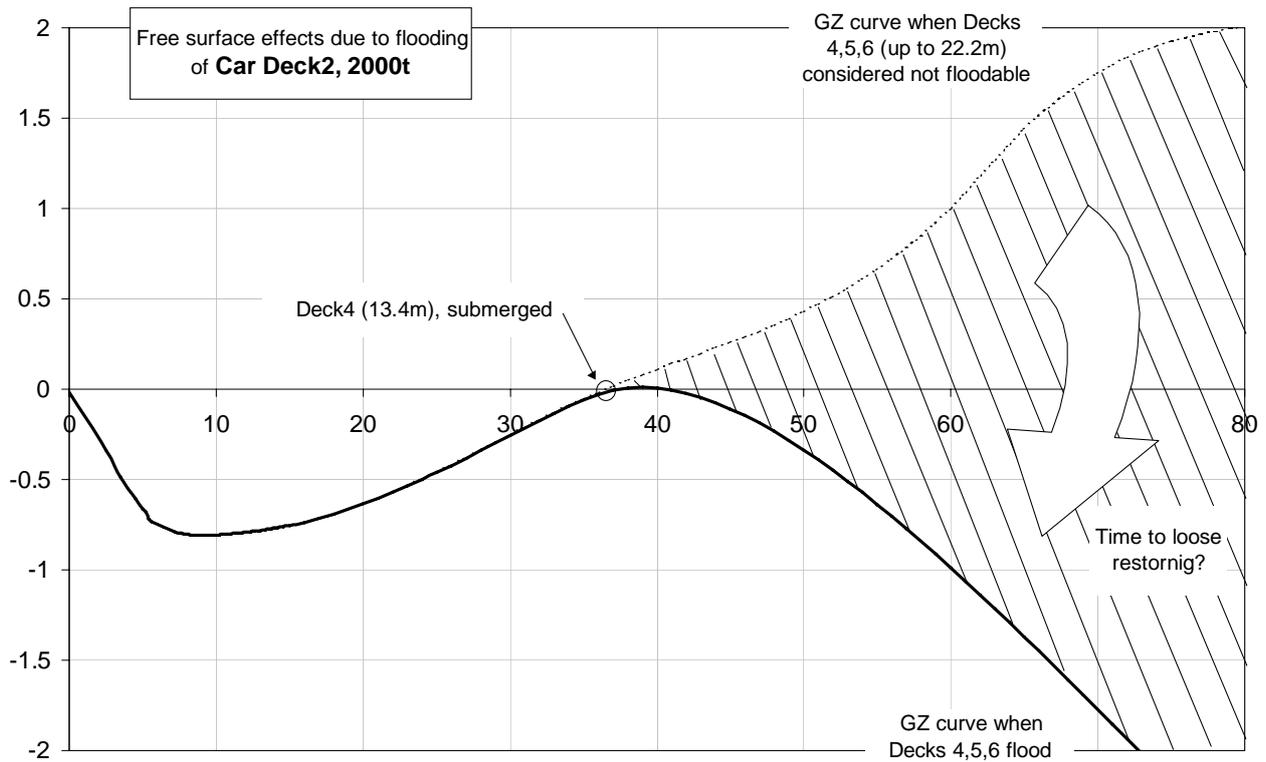
Figure 1: The process of flooding Decks 4, 5 and 6 takes place within a finite amount of time, estimated 13-28minutes if the JAIC statements were used as a reference base.

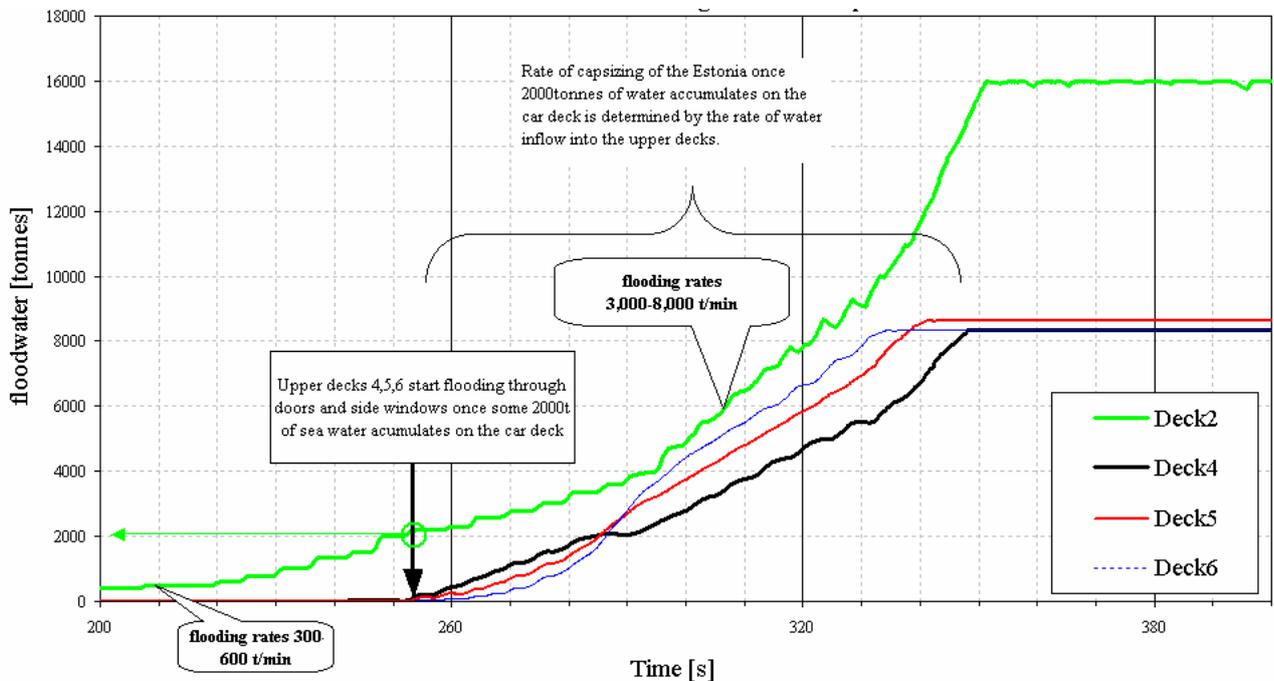
Figure 2 Estonia, Run136 (Figure 14 of [4]). Simulated typical flooding into Decks 2 (Car Deck) and Decks 4, 5 and 6 based on the JAIC scenario description. 15 windows assumed broken on each of upper decks with a total area of 20 m² for each deck. Car deck flooded through forward ramp.

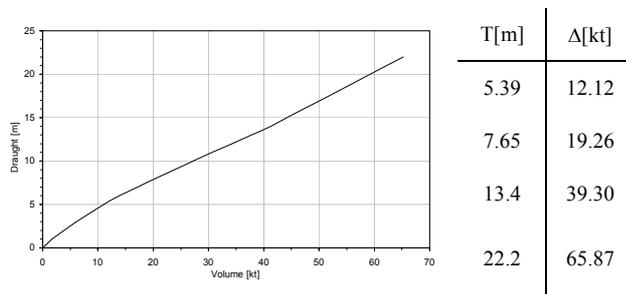
Figure 3: Underwater volume of the MV Estonia hull as a function of draught.

As can be seen in Figure 3, for MV Estonia to sink, with a capacity up to the top of the sixth deck at 22.2m of approximately 65,870 tonnes, a weight of 53,670 tonnes has to be added to her approximately 12,200 tonnes. Without going into details of permeabilities and exact geometries of the floodable spaces, this volume can be composed by flooding the accommodation decks 4, 5 and 6 collectively having a total capacity of approximately 26,000 tonnes, the car deck space with a capacity of about 20,000 tonnes including central casings (see Table 1 to Table 4 for more accurate estimates of the actual volumes of floodable spaces) and approximately 7,700 tonnes below the car deck space. Only then would the vessel lose her floatability.

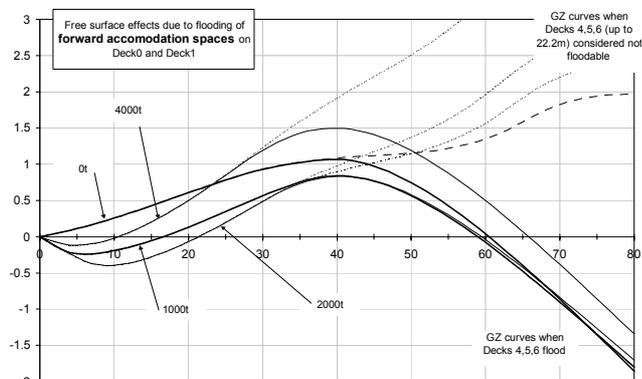
Figure 9: Free surface effects due to flooding of FS

Returning to free surface effect, Figure 9 demonstrates the ship restoring properties after partial flooding of spaces forward on Decks 0 and 1. Water is assumed to be uniformly distributed between the nine compartments, an overly conservative assumption, as normally the water would flow down to Deck 0 filling it, and thereby increasing ship stability, GM, at equilibrium angles (steepness of GZ curve at intersection with horizontal heel axis). As can be seen the largest heel angle of about 21deg results when the floodwater in the FS amounts to approximately 2,000 tonnes.

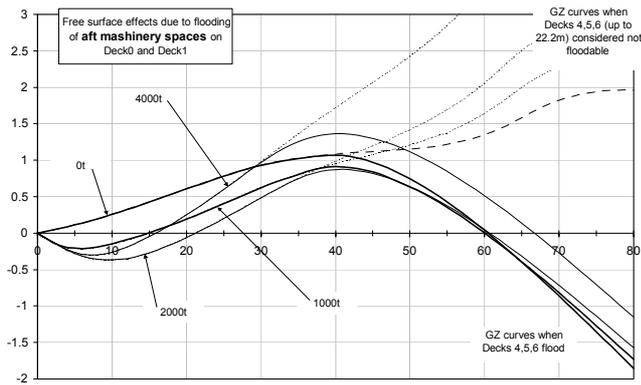
Figure 10: Free surface effects due to flooding of AS

In a similar manner it can be seen from Figure 10 that flooding of the aft spaces results in similar vessel stability characteristics as flooding of spaces forward, that is maximum heel of about 21deg is obtained with 2,000 tonnes of floodwater.

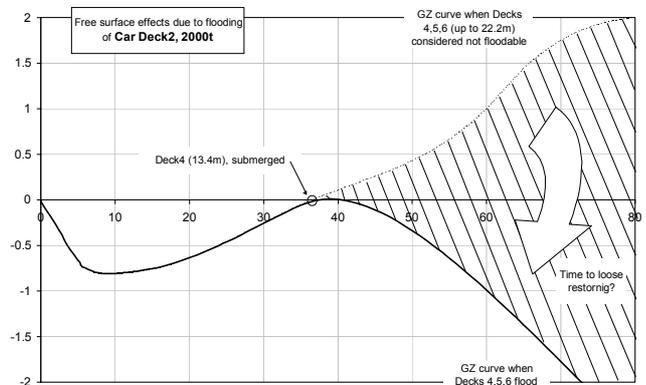
down within seconds. If, however, flooding of Decks 4, 5 and 6 takes place over hypothetically infinitely long period of time, the ship can float in equilibrium with 38deg heel. In reality, this flooding takes place within a finite time, spanning between a few seconds to a few minutes, as is demonstrated in Figure 12.

Figure 12: Process of flooding of Decks 4, 5 and 6 takes place within finite amount of time

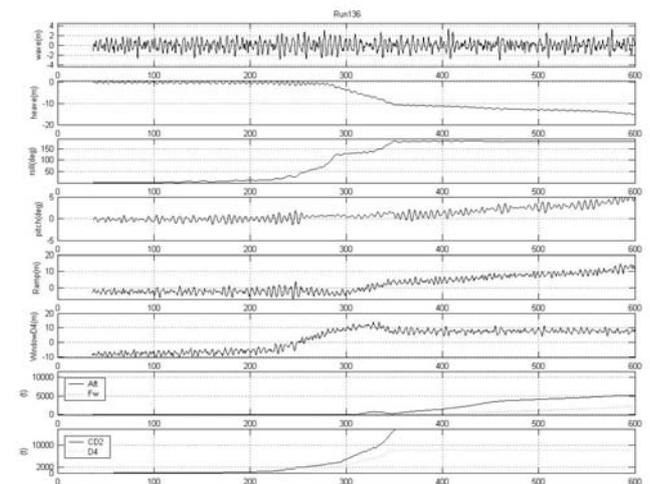
Figure 14: Time series of Scenario 1a: (1) wave, (2) heave, (3) roll, (4) pitch, (5) Relative motion at Ramp, [66.1, 0.0, 7.65], (6) Relative motion at the window in Deck 4, [-64.81, 12.11, 13.9], (7) Aggregate flooding into the forward and aft spaces below the car deck, (8) Aggregate flooding into the Car Deck and Deck 4.

It was found consistently that the vessel in such a scenario capsizes and floats upside down within 5-8 minutes from the beginning of the simulation. The average water inflow rates until an instant when 2,000 tonnes accumulates on the car deck, has been assessed to be between 300 and 600 [t/min]. Once the windows on Deck 4 become submerged (2,000 tonnes of water on the CD) the process of ship capsizing takes place within 2 minutes. A few hypothetical zero-speed cases considered revealed that the time to accumulate approximately 2,000 tonnes of water on deck increases approximately twofold. However, capsize still takes place within two minutes.

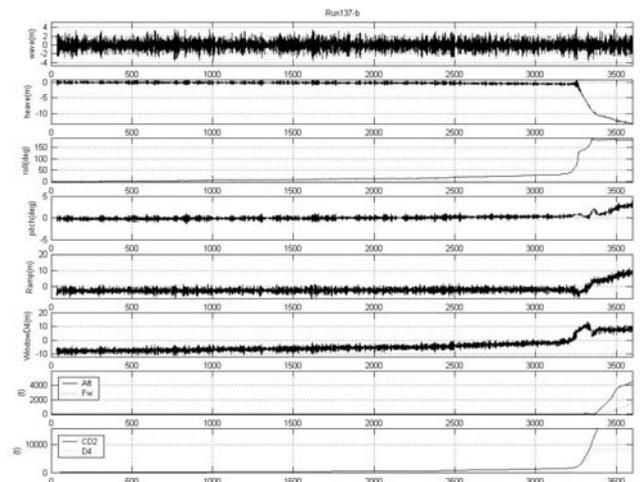
Figure 15: Time series of Scenario 1b

As can be seen in a typical example given in Figure 15, the time for the vessel to capsize is of the order of 45-60min. However, once the windows on Deck 4 submerge, the vessel capsizes within 2 minutes. This scenario on one hand confirms the uncertainty in assessing the rates of flooding the car deck, but on the other reaffirms the conclusion derived above that the JAIC description of sinking is lacking consistency. The vessel cannot float on her side with the superstructure flooded (as is taken for granted in JAIC statements), thus the spaces below cannot be flooded “from above”, and the vessel cannot sink.

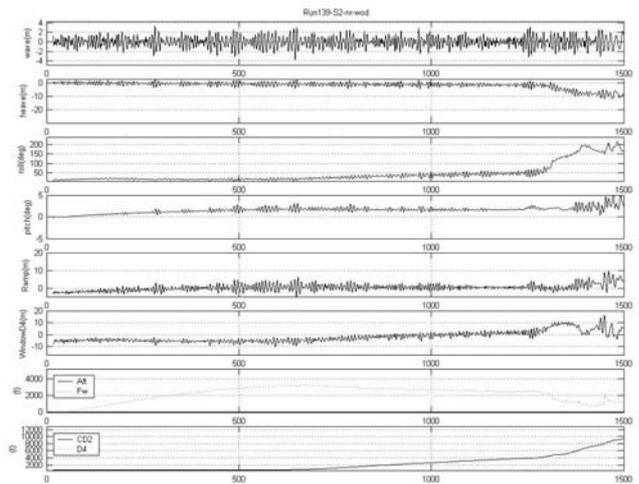
Figure 17: Time series of Scenario 2

As is shown in Figure 17, approximately 3,200 tonnes of water accumulate in forward spaces within about 10 minutes from the start of the simulation, resulting in a trim angle of some 2-2.5deg by the bow and subsequent loss of the forward freeboard. The heel angle to starboard side reaches approximately 15deg. Water starts flooding the CD “from below” through the doors in the centre casing (assumed opened), leading to heel angles up to about 30-40deg within 5-10 minutes, when the windows on Deck 4 submerge. Once this takes place the ship capsizes within 1-2 minutes.

Although not in agreement with any of the AB descriptions of causes of large heel angles, the conclusion from this test is that MV Estonia could capsize due to flooding of spaces below the car deck, deriving from the simple mechanism mentioned above. Once the vessel attains a given attitude (heeling mainly) the water level in the lower compartments can reach the doors leading to the car deck. Thus, once the car deck is flooded, the vessel will heel to the extent when windows on upper decks will be exposed to excessive pressures and breaking, with the spaces then undergoing progressive flooding. If this flooding is assumed to spread unobstructed, as is done in this simulation, the vessel will capsize quickly. Such a rapid capsize in this simulation demonstrates that no stabilising effects due to flooding of spaces below the CD are present, which rather undermines the opinion expressed in Quote 46.

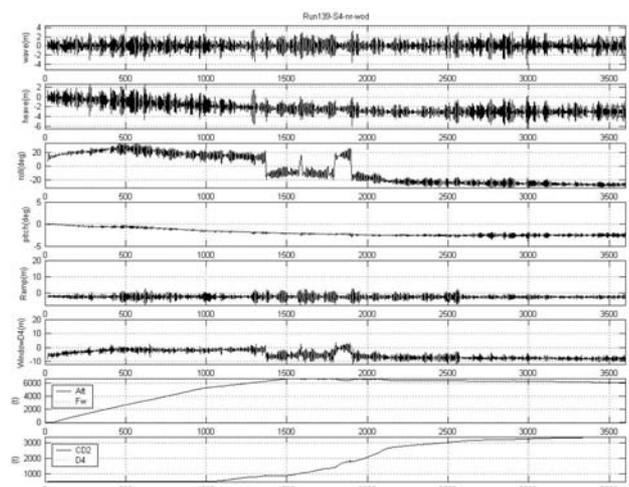
Figure 18: Time series of Scenario 3

Note here, that sinking with the stern first is very likely a result of the mode/sequence of flooding of the upper decks. Namely, as the vessel lies on her side, the aft parts of the superstructure could flood faster than the forward, and hence she could sink stern first.
