Research Study of Sinking Sequence of m/v ESTONIA

WP2.1 - Review of Evidence and Forming of Loss Hypothesis

10 October 2006

Technical Report

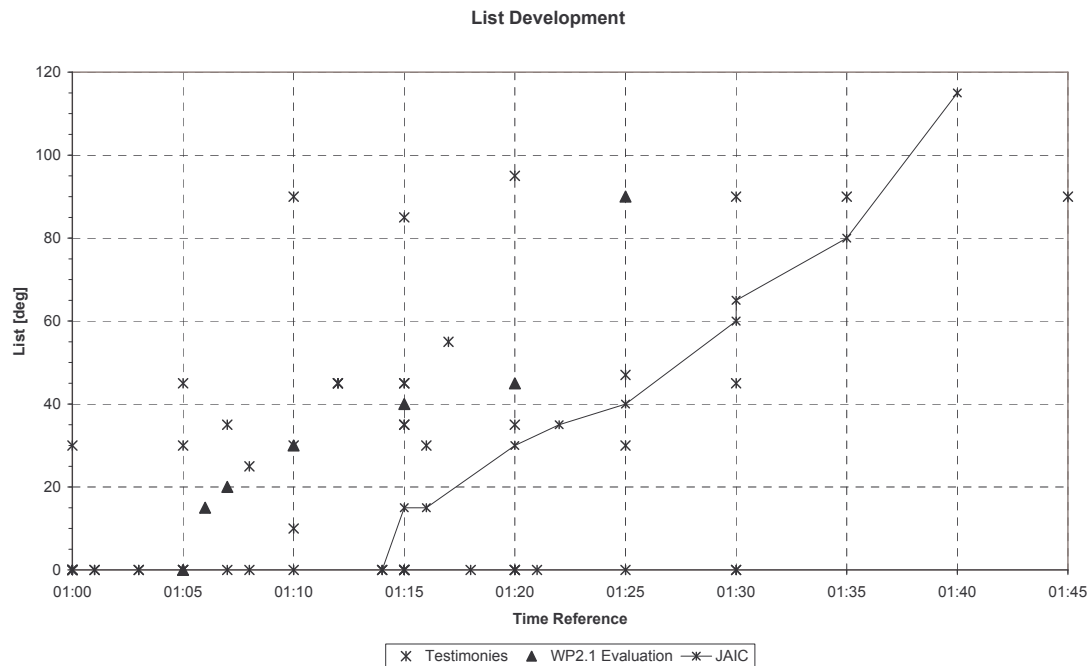
Figure 2 List Development

In order to depict the variance in perception of the events the list development v:s time has been plotted, see Figure 2.

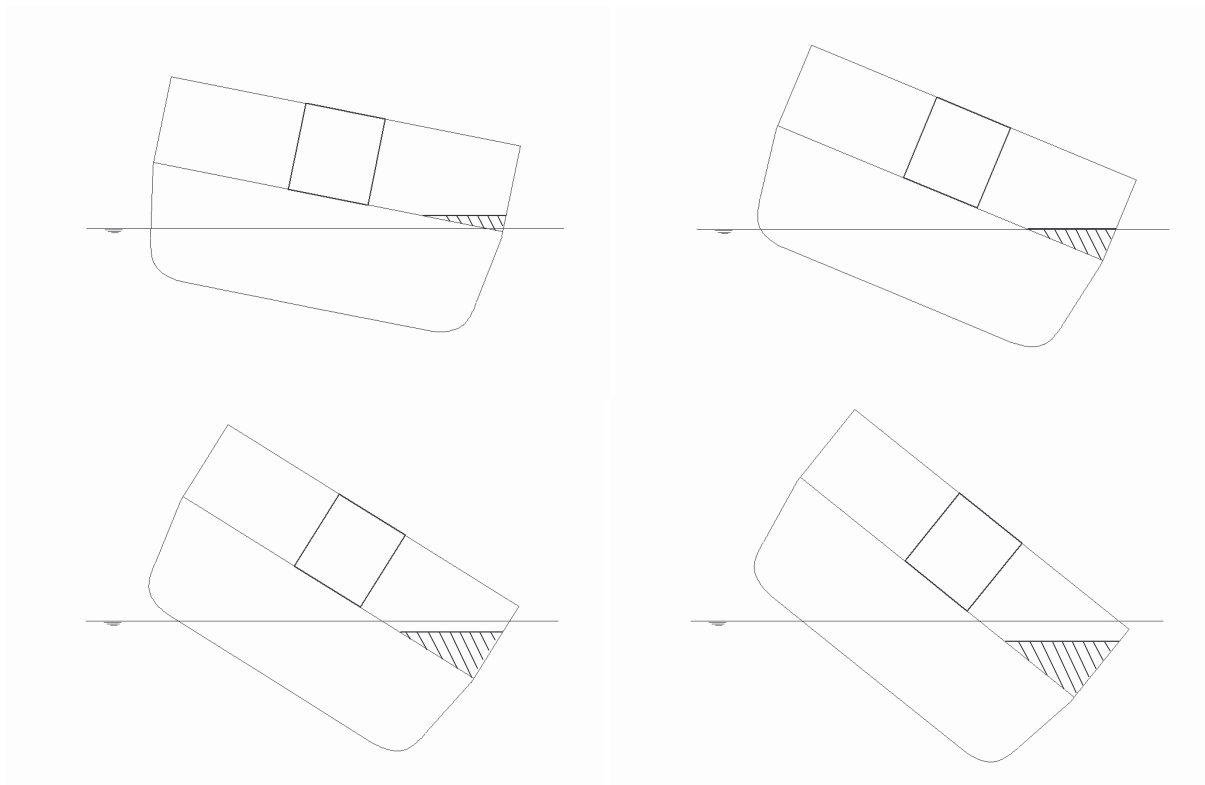
Figure 4 Ramp opening and floodwater level at equilibrium. Floodwater mass from above left: 400 t, 1000 t, 1600 t, 1900 t.

Water entering the car deck through the bow ramp opening will remain on the car deck even if no consideration of dynamic effects is made. This is mainly due to the narrow ramp opening in the centre line. This opening will be above the mean water level and the flooded water will be accumulated at the side of the car deck. The ship also has a trim by stern and the forward part of the deck has a slight slope towards the stern.

Figure 4 show the spatial relationships between ramp opening, floodwater level on the car deck and the outside mean water level for different stages of flooding.

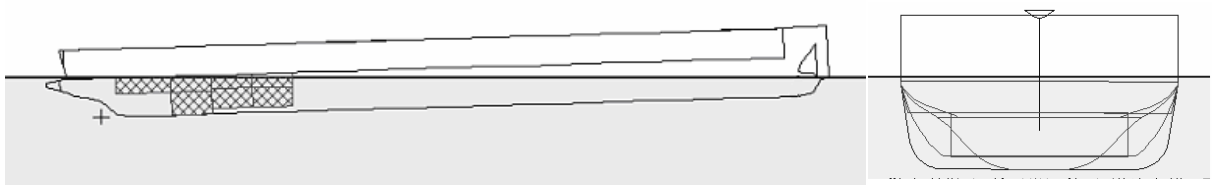
Figure 5 Symmetrical aft damage, equilibrium position.

Figure 5 shows the final equilibrium stage of a large aft damage case where the aft part of the centre casing is below the mean water line. Progressive flooding of the car deck will eventually lead to capsize. The damage includes the machinery spaces aft of the main engine room.

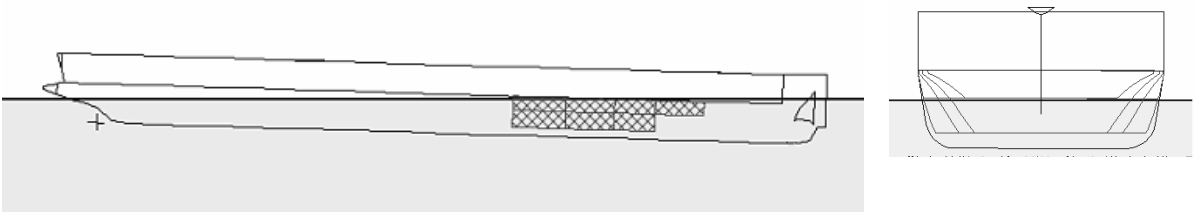
Figure 7 Symmetrical forward damage, equilibrium position.

Figure 7 shows the final equilibrium stage of a large damage in the forward accommodation area. The forward part of the car deck casing is below the mean water line. Progressive flooding of the car deck will eventually lead to capsize. The damage includes all but the two aft most compartments of the accommodation area below the bulkhead deck.

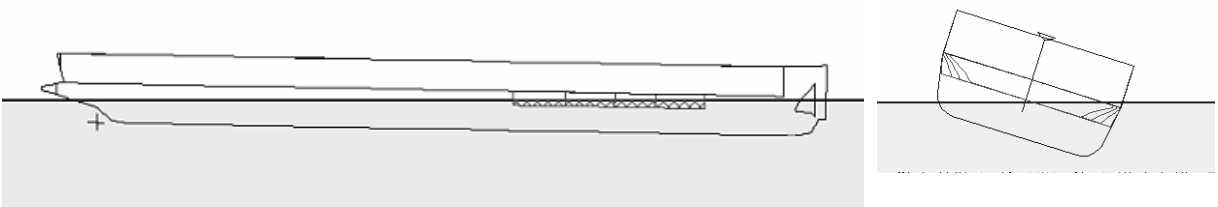
Figure 8 Symmetrical forward damage, intermediate stage. (Lower compartments 50% full.)

Figure 8 shows the same damage as above but at an intermediate stage of flooding where the three lower compartments are 50% full.

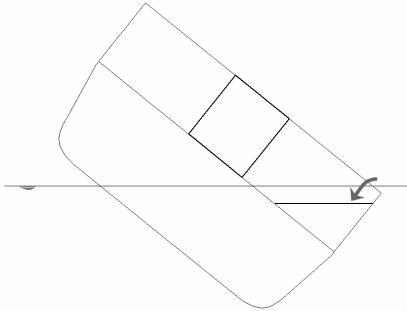
Figure 10 Water entering from car deck ventilation on deck 4.

Figure 10 shows the floating position with approximately 1 900 tonnes of water on the car deck. Close to this position water will enter through ventilation on deck 4.

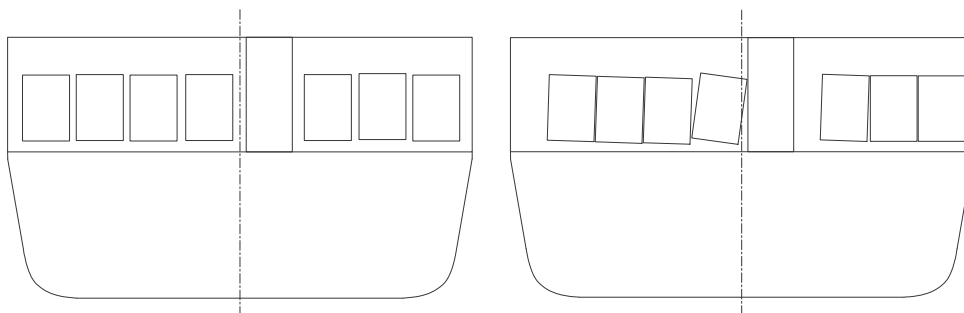
Figure 12 **Shifting of cargo of about 1 meter.**

Table 3 shows the effect of cargo shifting in intact condition. Cargo shifting above one meter would imply shifting of cargo inside of the carriers, Figure 12.

Cargo shifting could also cause damages on the ventilation ducts leading to the machinery spaces below the bulkhead deck, located at the sides of the car deck.

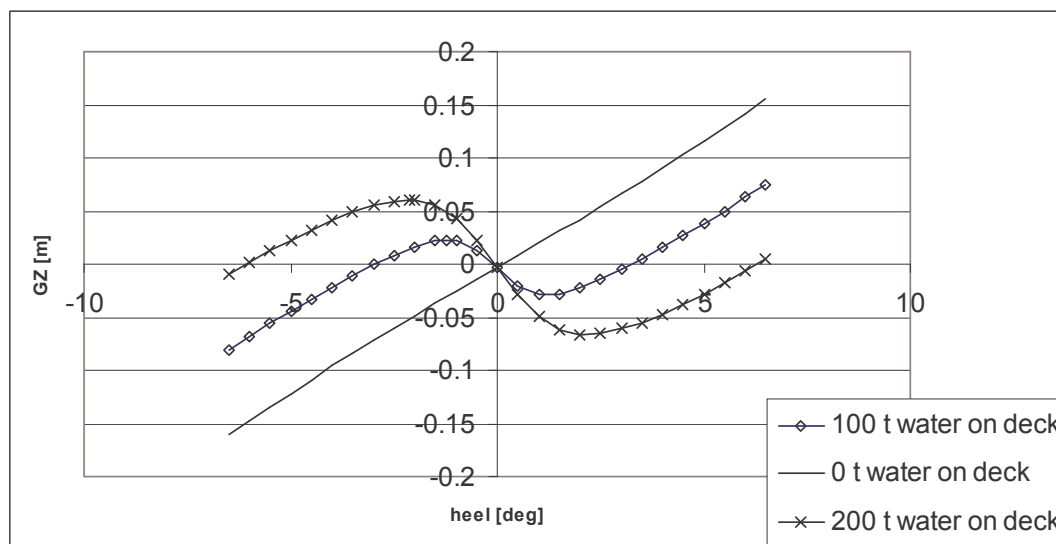
Figure 13 GZ curves with flooded car deck

Water on the car deck will lead to an unstable equilibrium at zero heel and the ship will reach a stable equilibrium at a certain list angle to the SB or PS. If the amount of water on deck is small enough however, the energy from the waves will make the ship pass through the unstable upright position i.e. the ship will roll through both stable equilibriums. The floodwater will go from side to side passing the centre casing and some of the water could possibly flood through openings in the centre casing down to the compartments below. Figure 13 show the GZ curve of the intact ship around probable roll angles together with GZ curves for 100t and 200t of water on the car deck. The potential energy i.e. area under the curves will not alone govern the roll motion of the ship but the curves can serve as rough estimates of the above phenomenon.

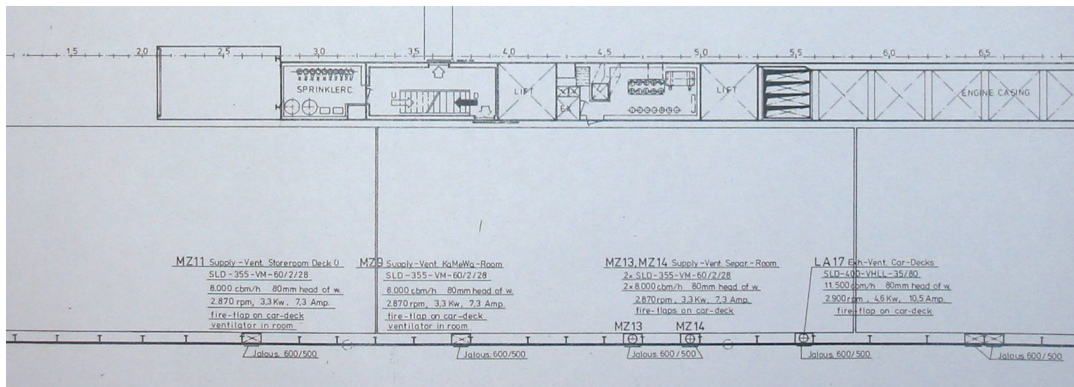
Figure 14 SB ventilation ducts on car deck. Centre casing at the top of the figure and SB side at the bottom

Ventilation ducts to spaces below the bulkhead deck are located on the inside of the outer hull. Each duct is located between two frames and is approximately 800 by 350 mm large. They are located in SB/PS pairs: One pair for each of stern tube/store room and KaMeWa room and two pairs for the separator room and for natural exhaust of the main engine room. The inlets of these ducts are located below deck 4, Figure 14.

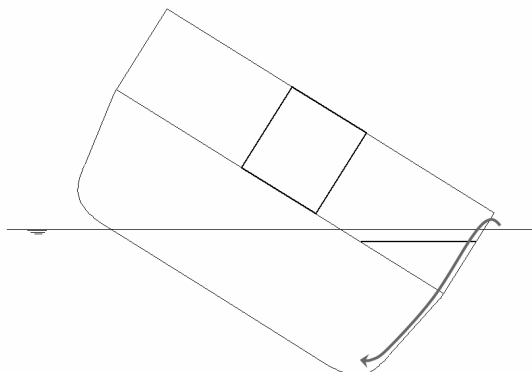
Figure 15 Flooding of spaces below the bulkhead deck through ventilation ducts.

In a scenario with water on deck only, these inlets will be submerged at a heel angle of 35-40 deg and about 1800 tonnes of water on deck, see Figure 15. The rate of flow through these six ducts is roughly estimated to a few hundred t/min with a pressure head of two meters, Appendix 2. This flood rate could be high enough for flooding of 7000 t during the sinking scenario. However these spaces can only contain up to about 4500 tonnes of water i.e. additional flooding below the bulkhead deck is necessary for the ship to sink. Damages on these ducts due to e.g. cargo shifting could have caused flooding from the car deck at an earlier stage.

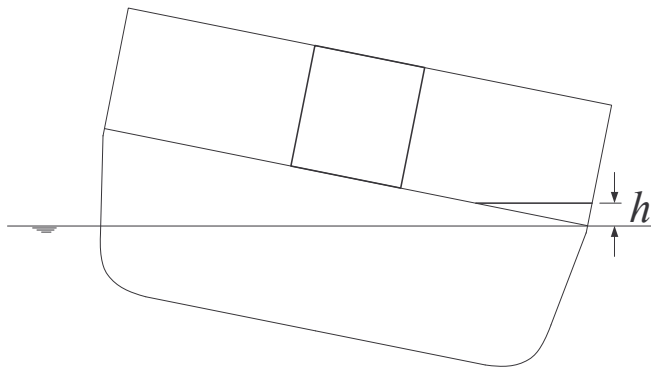
The pressure height is determined from the floating position depicted below.

This floating position, with about 400 tonnes of water on the car deck, represents the largest possible static pressure head due to water on the deck, with $h \approx 1$ m.
