Research Study on the Sinking Sequence of MV Estonia

WP2.2 Definition of foundering scenarios
WP3.5 CFD Computations and validations
WP4.1 Comprehensive modelling of MV Estonia

Project No.: *SaS0603-VIES01*
Reference No.: *VIES01-RE-001-AJ*
Report Date: *09 September 2006*
Report Type: *FINAL*
Report Status: *CONFIDENTIAL*

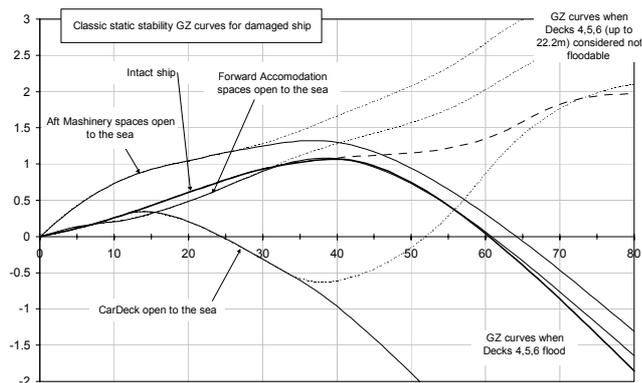
Figure 7: Classic static stability GZ curves for damaged ship

Figure 7 has been provided to demonstrate the properties of the GZ curves when flooding is considered in classical damage stability terms, that is when at every stage of flooding equalisation is reached between the floodwater level in the ship internal spaces and the outside sea. Little use can be made of such information in studies on ship behaviour as discussed here, as the process of this flooding is of fundamental importance in understanding the sequence of events leading to capsizing and/or sinking. Therefore, common assumptions of immediate flooding of the damaged spaces must be abandoned hereafter and consideration given to time factor in this process. This reasoning must address all spaces subjected to flooding, and in case of MV Estonia these are the spaces below the car deck, the CD itself and accommodation Decks 4, 5 and 6.

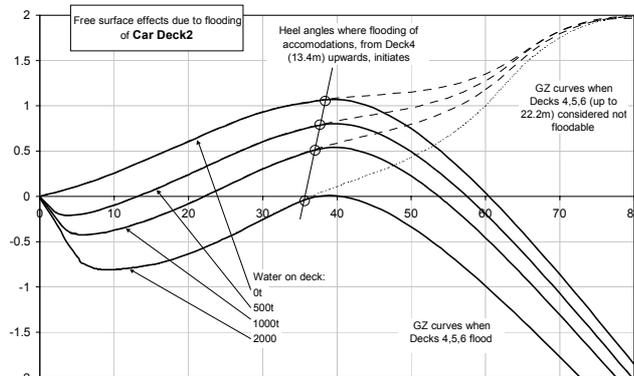
Figure 8: Free surface effects due to flooding of CD

Deriving from the above, the process of foundering can be analysed by focusing on some hypothesised intermediate stages of flooding and close examining the effect of free surfaces. In this respect, Figure 8 demonstrates that due to free surface effect, flooding of some 2,000 tonnes of water on the Car Deck results in heel angles of approximately 38deg, whereby the accommodation Deck 4 becomes submerged. Assuming that flooding of Decks 4, 5 and 6 happens instantaneously, as is the traditional naval architecture practice, the GZ curve at this point becomes negative, the vessel loses her stability and subsequently tips upside

down within seconds. If, however, flooding of Decks 4, 5 and 6 takes place over hypothetically infinitely long period of time, the ship can float in equilibrium with 38deg heel. In reality, this flooding takes place within a finite time, spanning between a few seconds to a few minutes, as is demonstrated in Figure 12.

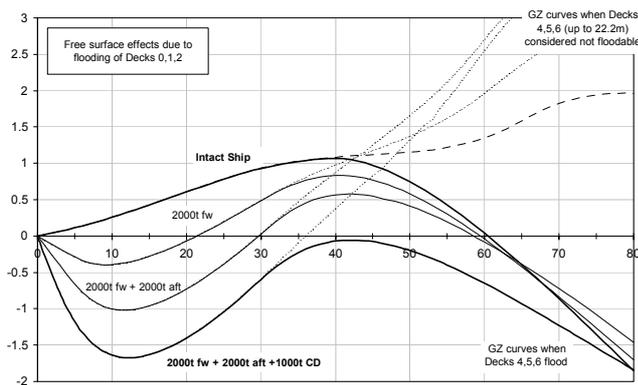
Figure 11: Free surface effects due to flooding of FS, AS and CD

It can be inferred from these arguments that flooding of either forward or aft spaces below the car deck cannot induce heel angles of more than 20-25deg. Note that the stability at equilibrium in each case is higher than the initial stability of intact ship. Moreover, in case of simultaneous flooding of both, the FS and the AS, a heel angle of not more than 30deg will be induced, see Figure 11.

Finally, by combining the information in Figure 8 and Figure 11, it can be indisputably deduced that for the vessel to stay in stable equilibrium with heel angles in excess of 40deg, that is to lie on her side, flooding of accommodation Decks 4, 5 and 6 must have taken place
