Research Study of Sinking Sequence of m/v ESTONIA

WP2.1 - Review of Evidence and Forming of Loss Hypothesis

10 October 2006

Technical Report

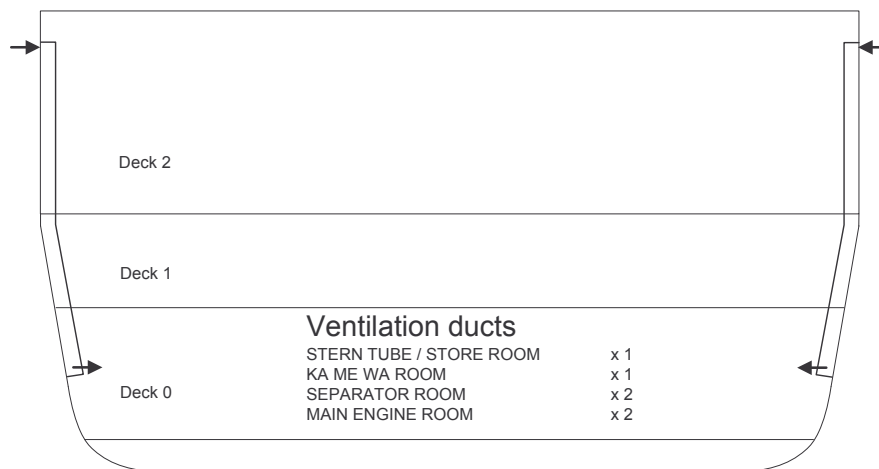
Figure 3 Principle arrangement of ventilation ducts.

- Ventilation ducts for spaces below the bulkhead deck which are located on the inside of the outer hull, each between two frames and with a size of approximately 800 by 350 mm, Figure 3 and Figure 15. They are located in SB/PS pairs: One pair for each of stern tube/store room and KaMeWa room and two pairs for the separator room and for natural exhaust of the main engine room. The inlets of these ducts are located below deck 4. These will be submerged at about 35° of heel.
- Car deck ventilators, terminating on deck 4. The ventilation openings are located at the ships sides just in front of the deck house and at the sides on the aft deck. These will be submerged at about 40° of heel.
- Four 800 by 350 mm exhaust ducts leading to the car deck, terminating in the ship sides below deck 4. These will be submerged at a heel angle of about 35° degrees.

The rate of flow through the six machinery space ventilation ducts is estimated to a few hundred tons/min with a pressure head of one meter.

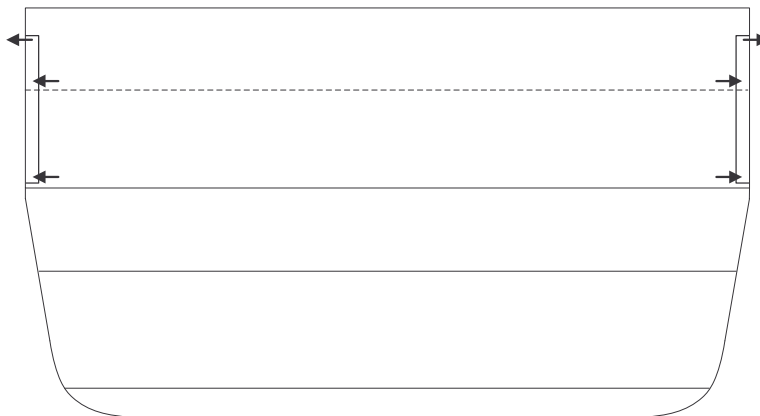
Figure 9 Principle arrangement of car deck exhaust ventilation ducts.

At a later stage of flooding water would enter through four 800 by 350 mm exhaust ducts in the ship sides below deck 4, Figure 9, and the large car deck ventilators on deck 4. The ventilation openings on deck 4 are located at the ships sides just in front of the super structure and at the sides on the aft deck, Figure 11. The water level inside the car deck will be below the mean water line when these openings are reached, at about 40° of heel, and the water inflow will increase. Located close to these forward and aft openings are also exhaust/supply ventilation of bow thrusters and steering gear as well as staircases reaching the four casings in the corners of the car deck.
